# Identification of failure mechanisms in retrieved fractured dental implants

Keren Shemtov-Yona\*, Daniel Rittel

Faculty of Mechanical Engineering, Technion, Israel Institute of Technology, Haifa, Israel

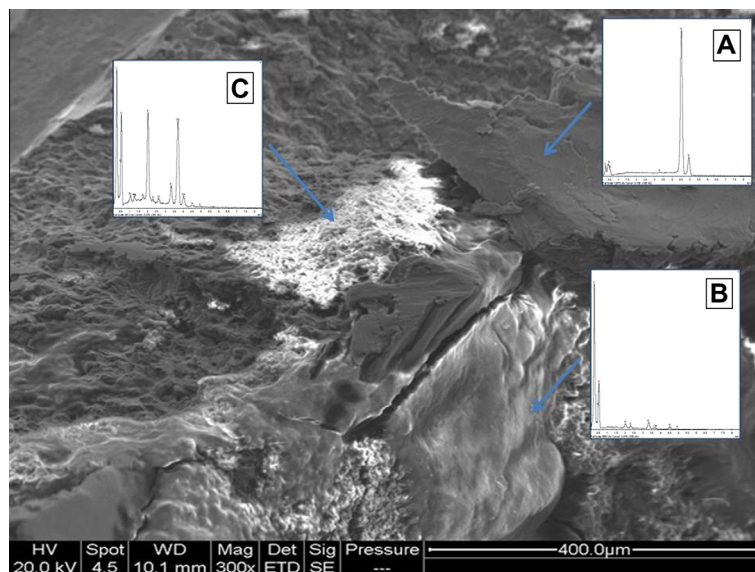
While identifying the metal composition of the retrieved fractured dental implants, one could notice that parts of the fracture surfaces were covered with different types of layers which were first identified using the EDX and subsequently removed in order to completely reveal the fracture surface. The composition of the layers was as follows:

1. Titanium – pure or alloy – the fracture surface itself.
2. Organic layer – consists mainly of carbon.
3. Inorganic layer – consist mainly of Ca/P – probably bone/calculus material.

**Fig. 1.** EDX analysis of example fracture surface of retrieved fractured CP-Ti dental implant. (A) The metal composition CP-Ti – The spectra shows high energy peak corresponds to CP-Ti. (B) Organic layer – The spectra show high energy peak corresponding to carbon. (C) Inorganic layer consisting mainly of Ca/P. The spectra show high energy peaks corresponding to calcium, phosphorus and oxygen.

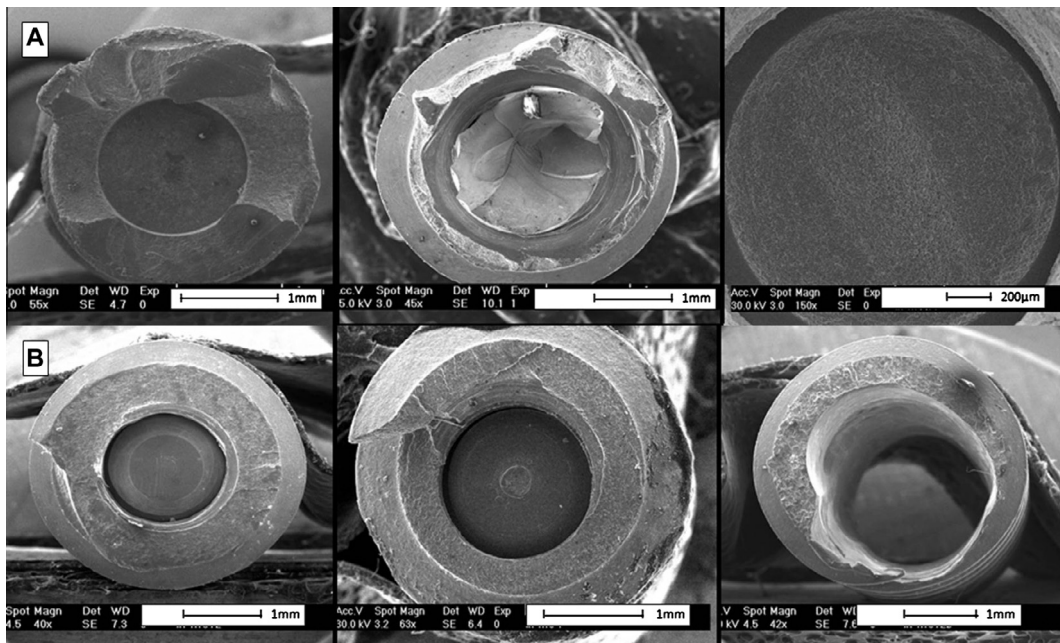
Fig. 2 shows representative macroscopic images of retrieved dental implants and implant's parts made of both CP-Ti and Ti-6Al-4V. The fracture surfaces clearly show, at low magnification, a generally uniform and flat fracture surface. This observation suggests the operation of a single failure mechanism until final failure of the implant.

**Fig. 2.** Macroscopic images of retrieved dental implants made of CP-Ti and Ti-6Al-4V. (A) Implants and implant's parts made of CP-Ti. (B) Implants and implant's parts made of Ti-6Al-4V.

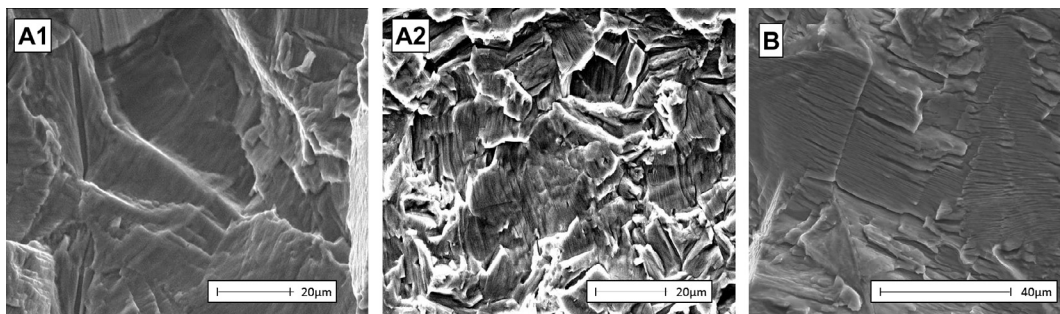
The fatigue fracture surfaces of retrieved CP-Ti dental implants show an overall trans-granular fracture with faceted crystallographic appearance or cleavage-like facets at magnification of 2–4 K with clear fatigue striations (Fig. 3A1 and A2). The

**Fig. 3.** Fractographs of CP-Ti dental implants. (A1) Retrieved dental implant. (A2) Retrieved dental implant. (B) Exemplar testing. A CP-Ti implant-like specimen was fractured in lab conditions in artificial saliva. The load magnitude was 1190 N the number of cycles to failure was 10,078. Note the high resemblance of the in vivo and in vitro fracture surface topographies.

fatigue fracture surfaces of CP-Ti implant-like specimens fractured in laboratory conditions, both in room air and in artificial saliva, show very similar fractographic features of a trans-granular fracture with faceted crystallographic appearance or cleavage-like facets with clear fatigue striations at the same magnification. Fig. 3B shows a typical fatigue fracture surface of a specimen tested in artificial saliva.

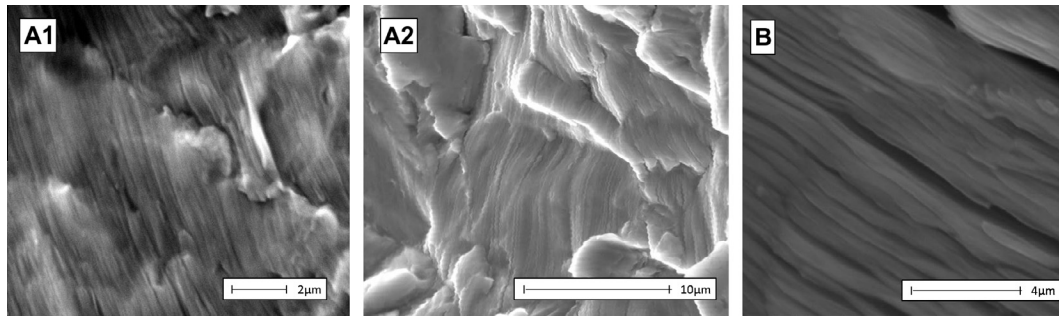
The typical fatigue striations can be identified easily at magnifications of (6 K), on the flat facets (Fig. 4), both on retrieved CP-Ti dental implants fractured intra-orally (Fig. 4A1 and A2) and on CP-Ti implant-like specimens fractured in lab conditions, air and artificial saliva (Fig. 4B).

**Fig. 4.** Fatigue striations in CP-Ti dental implants. (A1) Fatigue striations from retrieved implant. (A2) Fatigue striations from retrieved implant. (B) Fatigue striations from home-made CP-Ti implant-like specimen fractured in lab conditions and tested in artificial saliva. The load magnitude was 1190 N the number of cycles to failure was 10,078. Note the high resemblance of the in vivo and in vitro fracture surface topographies.

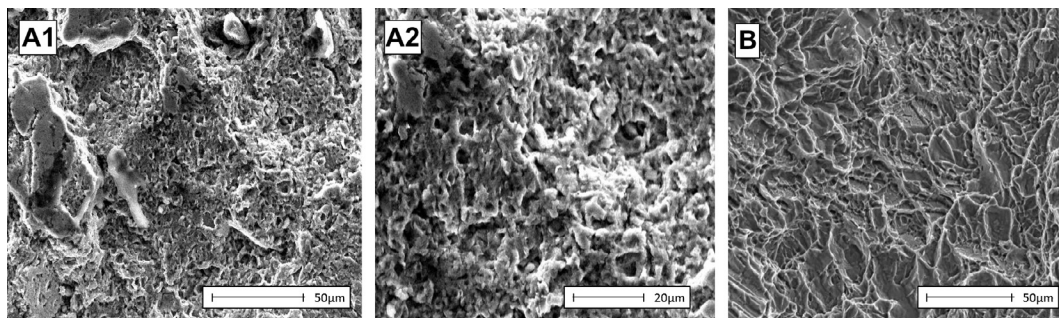
Final fracture marking, dimples, that are typical of ductile overload failure, can be identified on retrieved specimens on magnification of 1 K (Fig. 5A1 and A2). The area of overload fracture with dimpled structure is also shown at a magnification of 1 K, in a specimen tested in laboratory conditions, both in air and artificial saliva (Fig. 5B). One can again note the similarity of features between the in vivo and in vitro specimens.

**Fig. 5.** Final fracture in CP-Ti dental implants. (A1) Dimples from retrieved implant. (A2) Dimples from retrieved implant. (B) Dimples from CP-Ti implant-like specimen fractured in lab conditions tested in artificial saliva. The load magnitude was 1190 N. Note the high resemblance of the in vivo and in vitro fracture surface topographies.

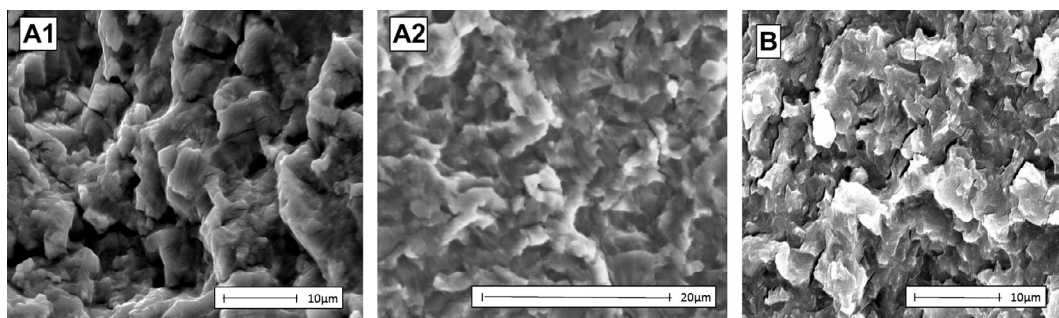
The fatigue fracture surfaces of retrieved Ti-6Al-4V dental implants show an overall trans-granular fracture with secondary cracking at magnification of 3–6 K (Fig. 6A1 and A2). The fatigue fracture surfaces of Ti-6Al-4V implants specimens fractured in lab conditions, both in room air and in artificial saliva show an overall similar fractographic appearance of a

**Fig. 6.** Fracture surface topography of Ti-6Al-4V dental implants. (A1) Fractograph taken from retrieved implants. (A2) Fractographs taken from retrieved implant. (B) Fractograph of Ti-6Al-4V dental implants fractured in lab conditions, tested in room air. The load magnitude was 714 N and the number of cycles to failure was 157,790. Note the high resemblance of the in vivo and in vitro fracture surface topographies.

trans-granular fracture with secondary cracking (Fig. 6B). Fatigue striation cannot be clearly identified (ill-defined). Fig. 7 shows faint classic fatigue striations that were identified on retrieved Ti-6Al-4V dental implants using magnifications as high as 15 K (Fig. 7A1 and A2). For specimens tested in lab conditions, the typical fatigue striations can only be identified in specimens fractured in room air environment at the same high magnifications (13 K, Fig. 7B).

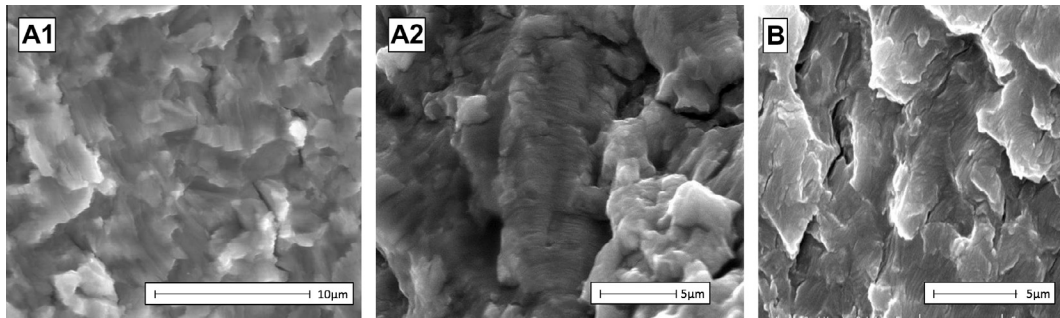
**Fig. 7.** Fatigue striations in Ti-6Al-4V dental implants. (A1) Fatigue striations from retrieved implant. (A2) Fatigue striations from retrieved implant. (B) Fatigue striations from Ti-6Al-4V dental implants fractured in lab conditions, tested in room air. The load magnitude was 714 N the number of cycles to failure was 157,790. Note the high resemblance of the in vivo and in vitro fracture surface topographies.

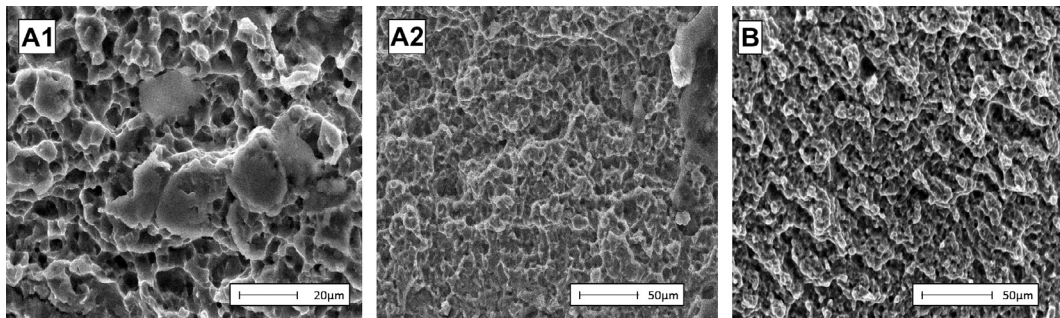
Final fracture marking, dimples, that are typical of ductile overload failure, can be identified on retrieved specimens on magnification of 1 K (Fig. 8A1 and A2). The area of overload fracture with dimpled structure is also shown at a magnification of 1 K, in a specimen tested in laboratory conditions, both in air and artificial saliva (Fig. 8B). One can again note the similarity of features between the in vivo and in vitro specimens.

**Fig. 8.** Final fracture in Ti-6Al-4V dental implants. (A1) Dimples from retrieved implant. (A2) Dimples from retrieved implant. (B) Dimples from Ti-6Al-4V dental implants fractured in lab conditions tested in room air the load magnitude was 714 N. Note the high resemblance of the in vivo and in vitro fracture surface topographies.
